Asbestos Demolition Survey

Kainga Ora Homes & Communities
Units 126 & 127
Arlington Street
Mount Cook
Wellington
6011

Report Number: S-14249/37184

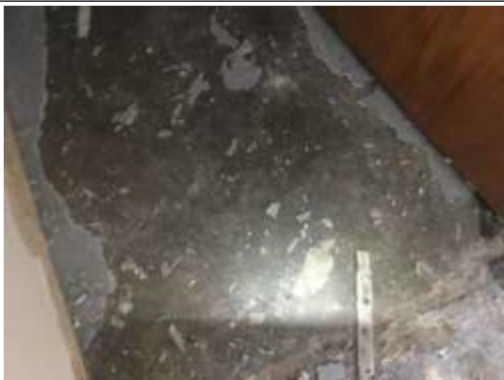
Building / Floor	Unit 126 / Ground Floor	
Location	015	Bathroom
Sample Number	S013/39914	
Item / Position	Residues to concrete beneath modern vinyl	
Material	Paper	
Extent (approx.)	5 m ²	
Product Type	AIB, textiles, gaskets, ropes, paper etc.	2
Condition	High damage or delamination of materials, sprays and thermal insulation. Visible asbestos debris.	3
Surface Treatment	Unsealed, B, textiles or encapsulated lagging and sprays	2
Asbestos Type	Chrysotile	1
Material Assessment	Medium	8
Recommendation	Remove

Comments	Material should be removed following asbestos procedures by an asbestos contractor holding appropriate licence in accordance with the regulations.
----------	--

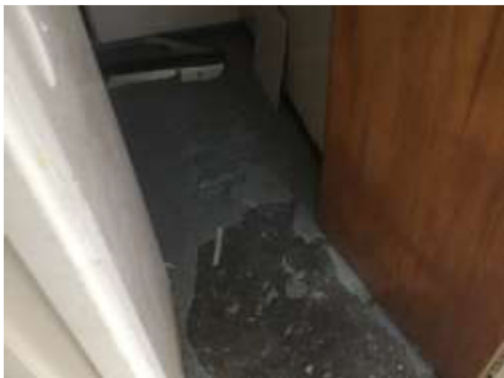
Building / Floor	Unit 126 / Ground Floor	
Location	014	Kitchen
Sample Number	S012/39913	
Item / Position	Residues to concrete beneath modern vinyl & screed - Under screed.	
Material	Paper	
Extent (approx.)	4 m ²	
Product Type	AIB, textiles, gaskets, ropes, paper etc.	2
Condition	High damage or delamination of materials, sprays and thermal insulation. Visible asbestos debris.	3
Surface Treatment	Enclosed sprays and lagging, AIB with exposed face painted or encapsulated, asbestos cements sheets etc	1
Asbestos Type	Chrysotile	1
Material Assessment	Medium	7
Recommendation	Remove

Material should be removed following asbestos procedures by an asbestos contractor holding appropriate licence in accordance with the regulations.

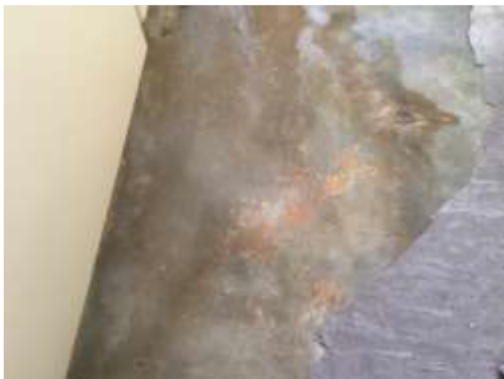
Building / Floor	Unit 127 / 1st Floor	
	Location	008	Kitchen
	Sample Number	S007/39908	
	Item / Position	Paper backed vinyl beneath modern vinyl & screed - Under screed.	
	Material	Vinyl with paper backing	
	Extent (approx.)	4 m ²	
	Product Type	AIB, textiles, gaskets, ropes, paper etc.	2
	Condition	Low damage - A few scratches or surface marks, broken edges on boards, tiles etc.	1
	Surface Treatment	Enclosed spaces and lagging, AIB with exposed face painted or encapsulated, asbestos cements sheets etc	1
	Asbestos Type	Chrysotile	1
Material Assessment	Low	5	
Recommendation	Remove		
Comments	Material should be removed following asbestos procedures by an asbestos contractor holding appropriate licence in accordance with the regulations.

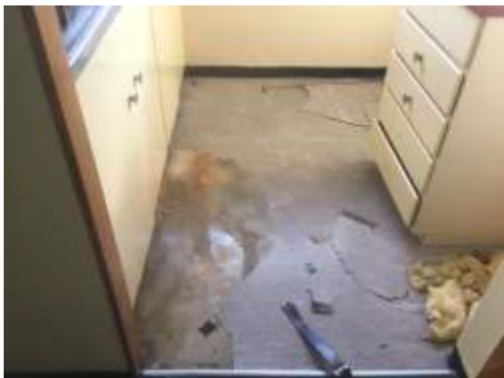
Building / Floor	Unit 127 / 1st Floor	
	Location	009	Bathroom
	Sample Number	X007/39908	
	Item / Position	Paper backed vinyl beneath modern vinyl	
	Material	Vinyl with paper backing	
	Extent (approx.)	5 m ²	
	Product Type	AIB, textiles, gaskets, ropes, paper etc.	2
	Condition	High damage or delamination of materials, sprays and thermal insulation. Visible asbestos debris.	3
	Surface Treatment	Enclosed sprays and lagging, AIB with exposed face painted or encapsulated, asbestos cements sheets etc	1
	Asbestos Type	Chrysotile	1
Comments	Material should be removed following asbestos procedures by an asbestos contractor holding appropriate licence in accordance with the regulations.		bestos contractor holding appropriate licence in

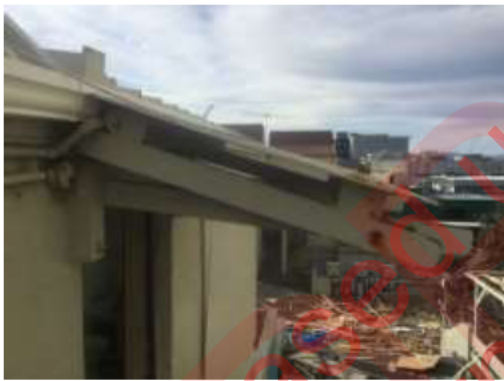
Building / Floor	Unit 126 & 127 / External	
	Location	099	External
	Sample Number	SP003	
	Item / Position	Canopy to flat 127 - Previously sampled as positive on other blocks	
	Material	Cement Product	
	Extent (approx.)	2 m ²	
	Product Type	Composites (plastics, resins, mastics, roofing felts, vinyl floor tiles, paints, decorative finishes, cement etc.)	1
	Condition	Medium damage - significant breakage of materials or several small areas where material has been damaged revealing loose asbestos fibres	2
	Surface Treatment	Enclosed sprays and lagging, AIB with exposed face painted or encapsulated, asbestos cements sheets etc	1
	Asbestos Type	Presumed 3	3
Comments	Material should be removed following asbestos procedures by an asbestos contractor holding appropriate licence in accordance with the regulations.

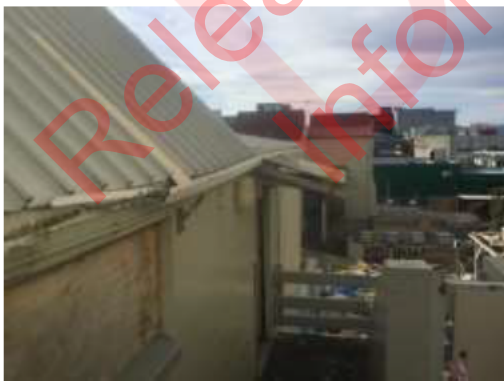
Building / Floor	Units 126 & 127 / External	
	Location	099	External
	Sample Number	SP001	
	Item / Position	Cement panels to walls of electric cupboard - Previously sampled as positive on other blocks	
	Material	Cement Product	
	Extent (approx.)	2 m ²	
	Product Type	Composites (plastics, resins, mastics, roofing felts, vinyl floor tiles, paints, decorative finishes, cement etc.)	1
	Condition	Medium damage - significant breakage of materials or several small areas where material has been damaged revealing loose asbestos fibr	2
	Surface Treatment	Enclosed sprays and lagging, AIB with exposed face painted or encapsulated, asbestos cements sheets etc	1
	Asbestos Type	Presumed 3	3
 	Material Assessment	Medium	7
	Recommendation	Remove	
	Comments	Material should be removed following asbestos procedures by an asbestos contractor holding appropriate licence in accordance with the regulations.
