Asbestos Demolition Survey

Kainga Ora Homes & Communities
Units 126 & 127
Arlington Street
Mount Cook
Wellington
6011

Report Number: S-14249/37184

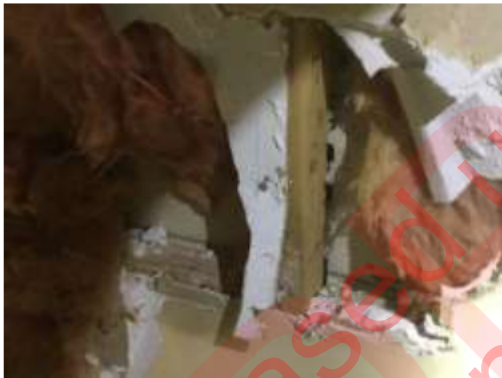
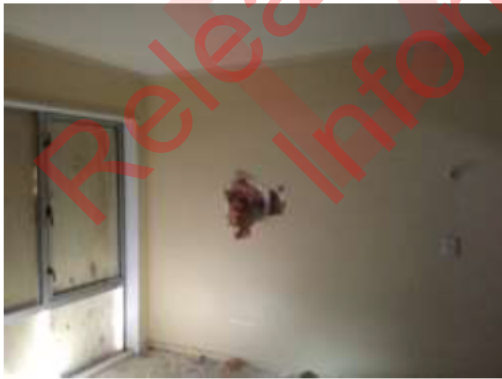
Building / Floor	Unit 127 / Throughout	
	Location	001	Throughout
	Sample Number	S005/39906	
	Item / Position	Packers to framework	
	Material	Bitumen/tar	
	Extent (approx.)	140 lin m	
	Product Type	-	-
	Condition	-	-
	Surface Treatment	-	-
	Asbestos Type	NAD	-
	Material Assessment	N/A	0
	Recommendation	No recommendation required	
Comments

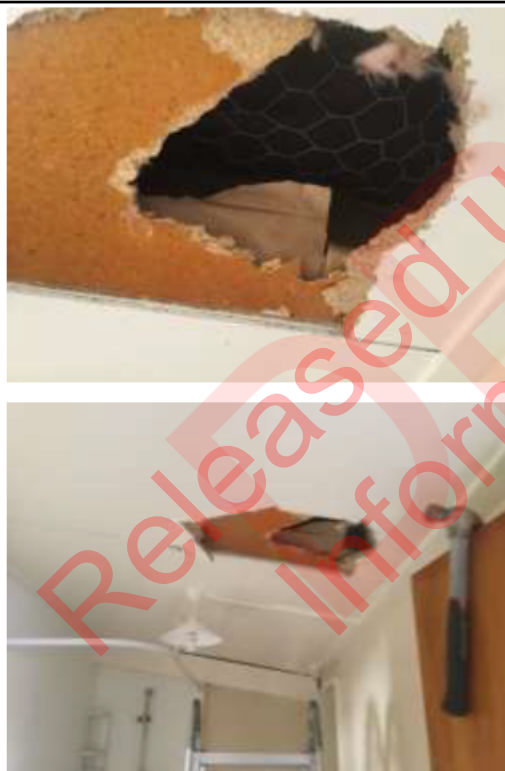
ing / Floor	it 127 / 1st Floor	
	L ation	01	Ceiling
	Sam le Numb	S008/39909	
	Item Po ion	Dust to lining paper above chipboard ceiling	
	Materia	Dust and debris	
	Extent (a rox.)	50 m²	
	Product Type	-	-
	Condition	-	-
	Surface Treatment	-	-
	Asbestos Type	NAD	-
Material Assessment	N/A	0	
Recommendation	No recommendation required		
Comments

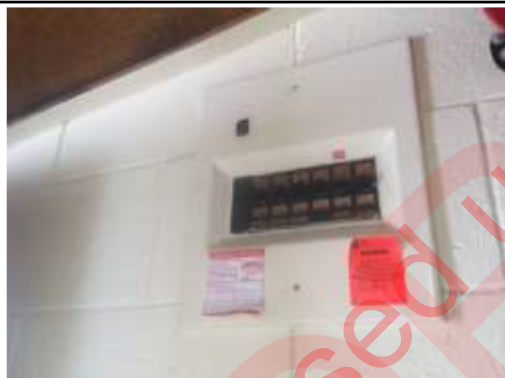
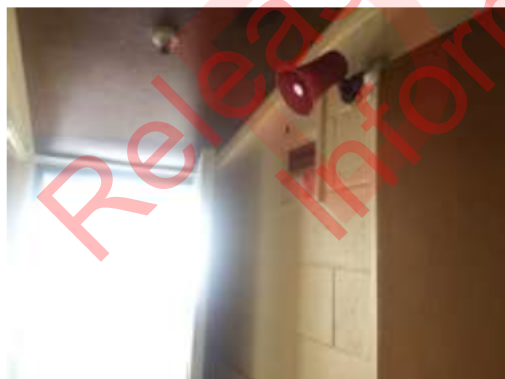
ing / Floor	it 126 / Ground Floor	
	L ation	01	Entrance
	Sam le Numb	X006/39907	
	Item Po ion	Switchboard	
	Materia	Bakelite	
	Extent (a rox.)	1 no	
	Product Type	-	-
	Condition	-	-
	Surface Treatment	-	-
	Asbestos Type	NAD	-
	Material Assessment	N/A	0
	Recommendation	No recommendation required	
Comments
